# CASE STUDY

## Warwick Hospital

The Project: Warwick Hospital Management Building, Warwickshire

Sprayfoam Contractor: Spray Foam Solutions Ltd  
Scope of Project: To spray a 155mm coat of BASF Walltite to the under side of a slate roof.

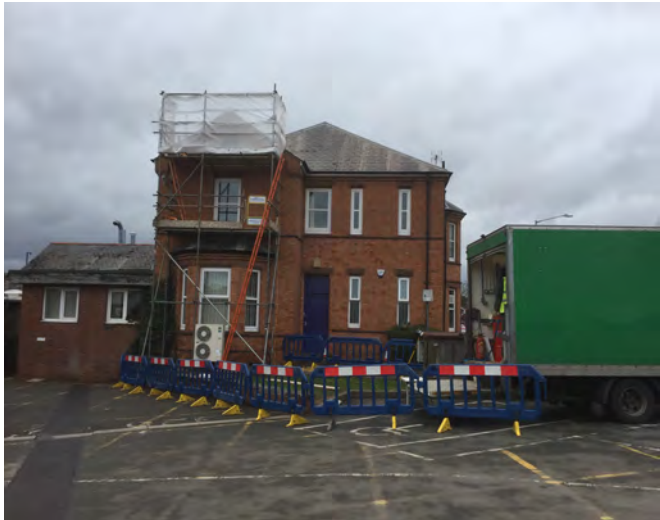
Figure 1 The scaffolded exterior of the Management Building

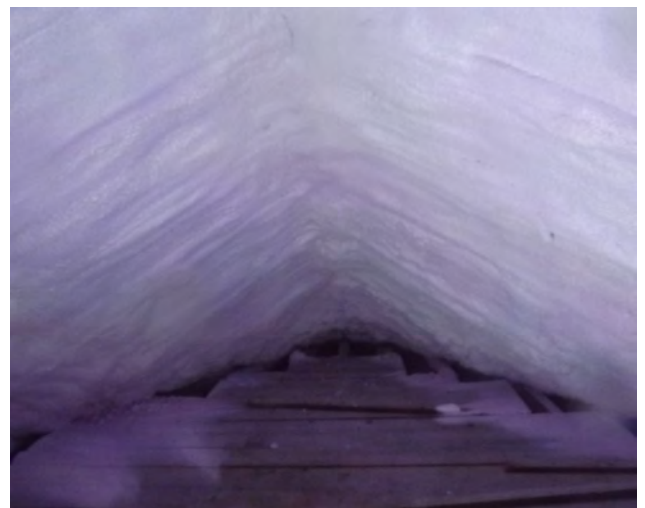
Figure 2 A seamless coat of Walltite.

BASF Walltite Closed cell foam was specified. Sprayed directly to the back of the slate roof, minimising air leakage and stabilizing the old roof slates in position.
